Facilities Assessment Report

July 25, 2017

Introduction

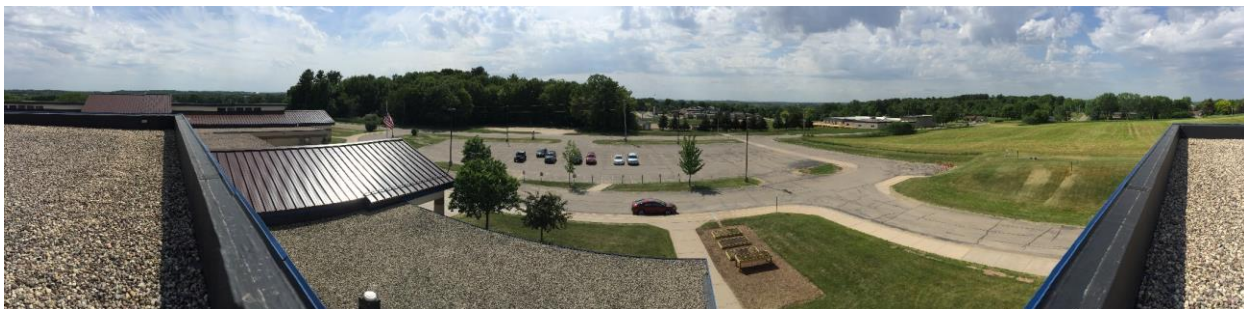
Traffic circulation between bus, parent and staff traffic is difficult. Several different patterns and options have been tried by administration to alleviate congestion, confusion and issues including having staff direct traffic. These attempts have met with various success. The two main challenges for site circulation are lack of clear wayfinding for traffic and the lack of a road that loops the entire school. A road looping the school would allow bus and parent traffic to drop-off at different sides of the school.

Pavement condition is poor. The district has noted the desire to resolve site circulation issues in conjunction with repairing pavement deterioration.

1. Rework MES site at main parking lot to improve site circulation safety, replace poor asphalt, and add loop route around the school. The revisions will allow the separation of parent drop-off from bus drop-off.

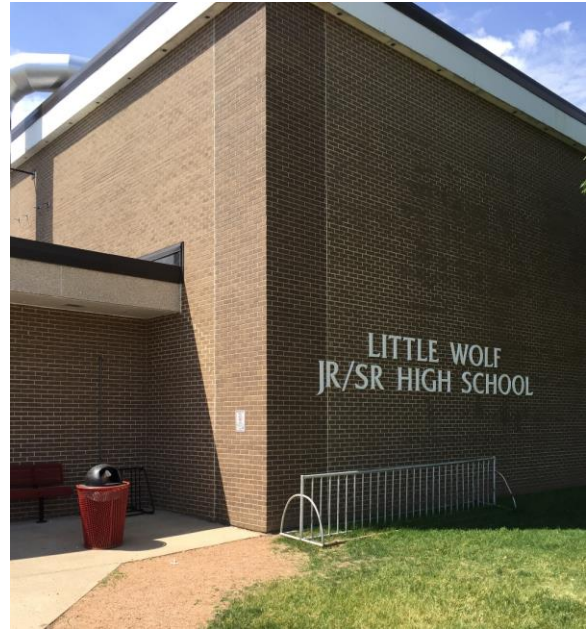
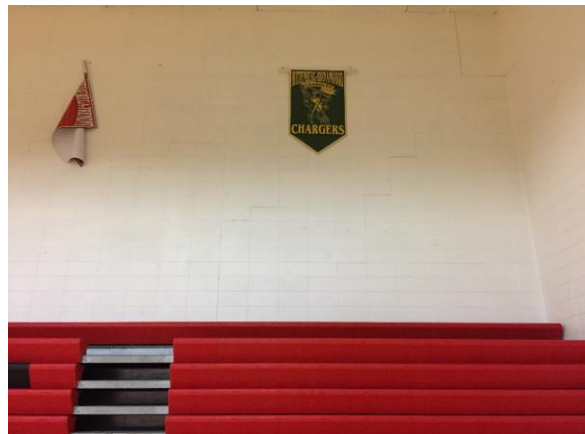
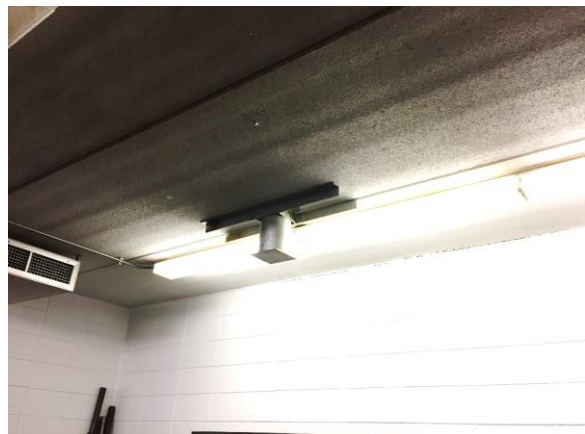
The masonry on the exterior of the upper walls of the commons are bowed and showing signs of movement. These walls do not have vertical expansion joints at the minimum recommended spacing. Additionally, the wall shows signs of the brick masonry veneer pulling away from the

2. To maintain integrity and weather tightness of exterior wall structure, install vertical expansion joints in all masonry veneer per industry standard recommendations for location, frequency and sealants. When joints are installed on upper walls of commons, evaluate and repair bowing masonry wall as required.

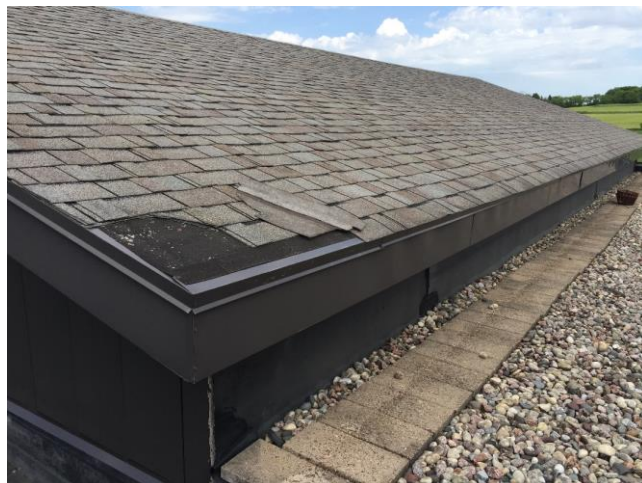
Vegetation is growing on several areas of the roof and trees are overhanging portions of the roof.

16. Replace asphalt shingle roofs with new shingle or standing seam metal roofs.
17. Remove vegetation from roof and from overhanging roof.
18. Attach roof ladder to wall at commons roof.

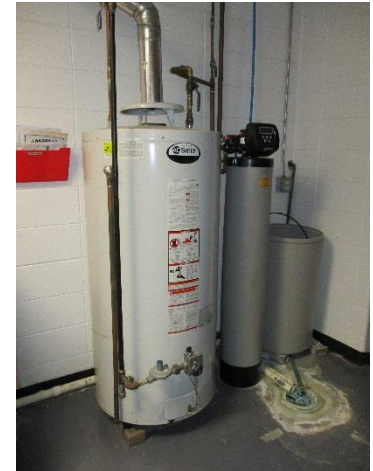
Photo: Kitchen Water Heater

The existing domestic gas-fired water heaters and storage tank should be replaced immediately upon available funding for equipment replacement. Water heaters have been serviced over the years and are beyond repairs. The existing domestic kitchen gas-fired water heater is relatively new and can remain in place.

20. The two existing domestic gas-fired water heaters 120 MBH and storage tank should be replaced immediately upon receipt of available funding for equipment replacement. The water heaters are beyond repair. The recirculation pumps should be replaced with the water heater replacement.

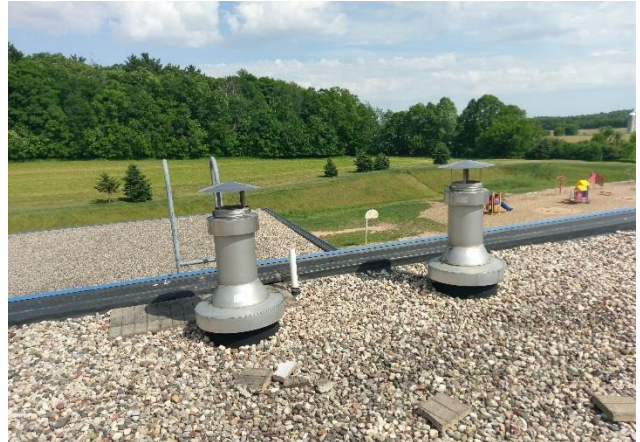
Photo: Existing Boiler's Breeching Stacks

The hot water boilers have been maintained over the years. However, these particular boilers are at the end of their useful life. One of two boilers is not functioning while the other has difficulty staying on. It is recommended that both boilers be replaced with high efficiency condensing boilers (minimum of three) sized at 40% capacity. New high efficiency boilers are recommended to have integrated controls and alarms with a Building Automation System (BAS). The breeching stacks also need to be modified. If boilers and domestic hot water heaters are to be replaced with condensing appliances, the existing combustion air handling unit AHU-6 should be removed at same time.

21. Replace existing two hot water boilers 2,000 MBH with high efficiency condensing boilers (minimum of three) sized at 40% capacity. The existing boilers are at the end of their useful life. One of two boilers is not functioning while the other has difficulty staying on.

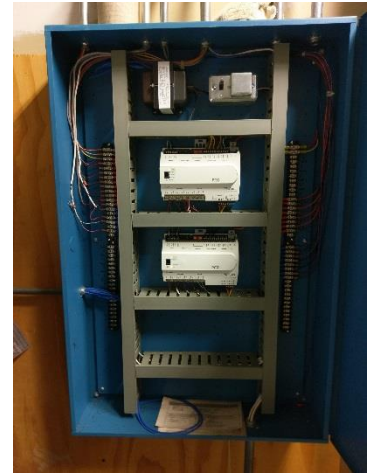
Photo: JCI Controllers

The building temperature controls are Direct Digital Controls (DDC) with electric actuation. The original controls were upgraded recently to Trane Control devices with the 2014 roof equipment replacement project. Overall network DDC controllers serve the existing rooftop air handlers and unitary equipment. There are some JCI controllers and devices which serve the 1995 Addition. JCI controllers are over 22 years and are obsolete controls.

The building temperature controls should be upgraded to Direct Digital Control (DDC) as part of any future building renovation or facility improvement measure. It is recommended that the temperature controls be upgraded to new DDC controller with a fully automated system, complete with software and graphics. Monitoring and adjustment of building systems and zone set points should be available through an operator workstation.

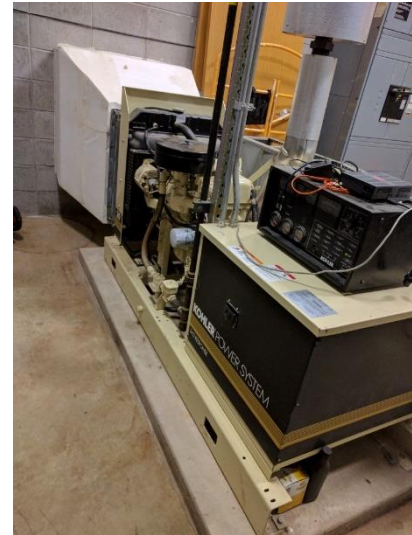
Photo: Generator

The emergency system is currently serving egress lighting as well as telecommunications load.

11. Replace deteriorated or missing sealant.
12. Replace windows.
13. Paint exterior doors which are only primed.
14. Replace existing generator and relocate away from building switchboard.

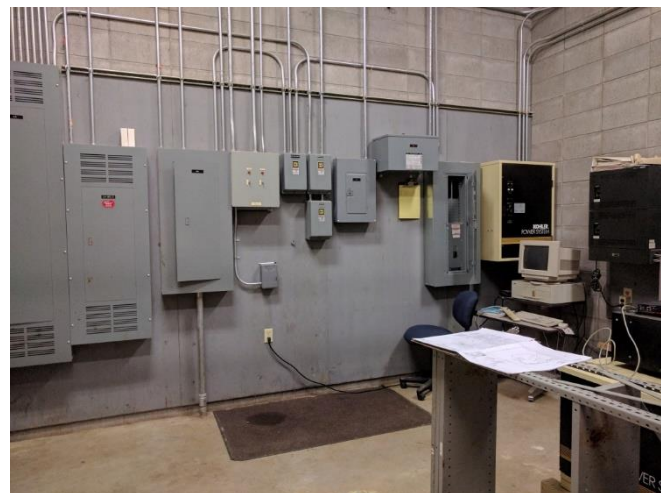
Photo: Panelboards and Transfer Switch

Existing generator fed loads are part of NEC 700 (emergency) and NEC 701 (legally required) branches of power. Per NEC 700.10(B) these branches of power are required to be segregated which will require the addition of a transfer switch and panelboard so that the 701 loads can be removed from the 700 branch of power. In addition, all downstream branch wiring requires segregation from each other, as well as from the normal power branch wiring. It is recommended that this branch wiring be re-done in new 700 and 701 dedicated raceways.

15. Emergency and standby power are not segregated.
16. Add surge suppression to emergency system.
17. Replace the fire alarm system entirely with a new system that is speaker based and provide full intelligibility.
