**SCHOOL DISTRICT OF MANAWA
BUILDINGS & GROUNDS COMMITTEE MEETING
AGENDA**

Date: December 16, 2020

Customer Hosted Renewable Solutions Proposal

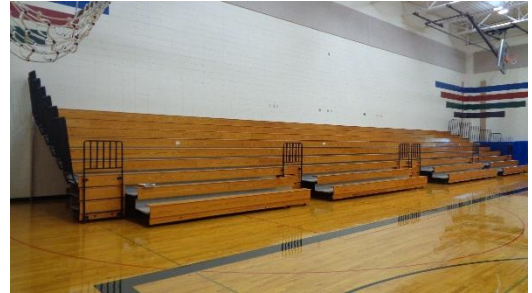
Manufacturer: FBC
 Model: G2
 4 Sections, 9 Rows
 2 Sections, 4 Rows
 Estimated Gross Seating: 587
 Operation: Powered
 Surface: Wood
 Estimated Replacement Cost: \$ 60,000

Overall Rating: Fair	▲	General maintenance, service & upgrades needed
IBC ICC/ANSI 300-2015, Chapter 5		
Understructure: Service	▲	Maintain lubrication, check, tighten exposed fasteners and anchors
Surface: Ok	✓	Check, tighten exposed fasteners
Guards/Rails: FAIL	Code	Top row end rails do not meet required 42" height code (9-row)
Deck Gaps: Ok	✓	
Aisle ways/Egress: Upgrade	▲	Aisle system needed to meet egress codes
Power System: Upgrade	◆	Replace worn drive rollers to restore traction (9-row)
Wheelchair Spaces: Ok	✓	ADA compliant
Athletic Equipment: Service	▲	Yearly service recommended, maintain safe operation

- US 1 ▪ Lubrication needs to be maintained.
- US 3 ▪ Safety rowlocks need service/repair for safe, even operation and row stability.
- US 4 ▪ Check and tighten loose and missing anchors and frame fasteners, replace as needed.

- SF 2 ▪ Check and tighten loose and missing exposed surface fasteners, replace as needed.
- PR 1 ▪ Power unit drive rollers are in poor condition and are spinning and losing traction. Drive roller replacement with BR Bulldog™ Power Drive Rollers needed to restore traction and improve operation. Spinning drive rollers can damage the surfaces, further reducing traction and increasing uneven operation and short, crooked rows. (9-row)

- RE 1 ▪ Top row end rails need replacement to meet required* 42" height code. (9-row)
- AL 1 ▪ Aisle system with center handrails and 48" intermediate steps is needed for safety and will meet egress code.

- AE 1 ▪ Basketball Backstop and athletic equipment safety inspection and service recommended.

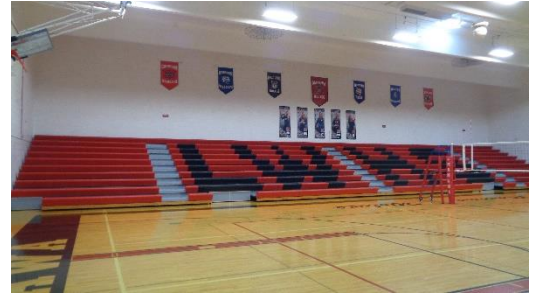
Manufacturer: Interkal
 Model: G3
 4 Sections, 10 Rows
 4 Sections, 9 Rows
 Estimated Gross Seating: 1171
 Operation: Powered
 Surface: Plastic
 Estimated Replacement Cost: \$ 119,000

Overall Rating:	Ok to Fair	▲	General maintenance, service & upgrades needed
IBC ICC/ANSI 300-2015, Chapter 5			
Understructure:	Service	▲	Maintain lubrication, check, tighten exposed fasteners and anchors
Surface:	Ok	✓	Check, tighten exposed fasteners
Guards/Rails:	Ok	✓	Check, adjust, tighten as needed
Deck Gaps:	Ok	✓	
Aisle ways/Egress:	Upgrade	▲	Aisle system does not meet egress codes
Power System:	Service	▲	Clean power system for traction
Wheelchair Spaces:	Ok	✓	ADA compliant
Athletic Equipment:	Service	▲	Yearly service recommended, maintain safe operation
	Upgrade	▲	Install basketball backstop safety straps recommended

- US 1 ▪ Lubrication needs to be maintained.
- US 3 ▪ Safety rowlocks need service/repair for safe, even operation and row stability.
- US 4 ▪ Check and tighten loose and missing anchors and frame fasteners, replace as needed.

- SF 2 ▪ Check and tighten loose and missing exposed plastic modules surface fasteners, replace as needed.
Note: Plastic seat modules' loose condition may be due to loose internal hardware or damage to the module. No service or repair work for plastic seat modules is included. Replacement plastic seat modules specially ordered and subject to manufacturer's availability.

- PR 1 ▪ Power unit drive rollers need cleaning to restore traction and even operation. Spinning drive rollers can damage the surfaces, further reducing traction.

- AE 1 ▪ Basketball Backstop and athletic equipment safety inspection and service recommended.
- AE 2 ▪ Install safety straps on all retractable basketball backstops.

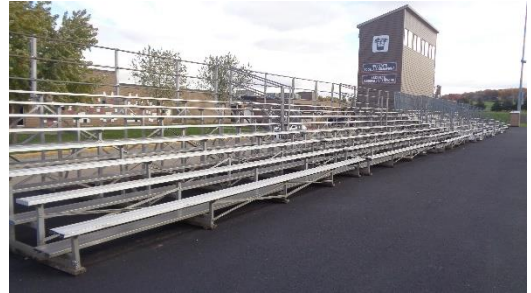
Manufacturer: Unknown
 Type: Non-Elevated Angle Frame
 Surface: Aluminum
 Grounding: Freestanding
 4 Sections, 8 Rows x 24' long
 3 Sections, 8 Rows x 21' long
 Estimated Gross Seating: 848

Overall Rating:	Fair	▲	General maintenance service and upgrades needed
IBC ICC/ANSI 300-2015, Chapter 5			
Understructure:	Service	▲	Check, tighten & replace missing frame fasteners
	Upgrade	▲	Structural anchors recommended
Surface:	Service	▲	Check, tighten & replace missing fasteners
Front, End & Rear Rails:	FAIL	Code	End and rear rail systems do not meet required 4" gap code (24' stands)
Deck Gaps:	FAIL	Code	Deck gaps do not meet required 4" gap code
Aisle ways/Egress:	Upgrade	▲	Aisle system needed to meet egress codes (24' stands)

- US 1 ▪ General service of the fasteners for the framework, rails, and surface.
- US 2 ▪ Ground slab anchoring needed to prevent wind overturning.
- RE 1 ▪ End rail system meets existing bleacher codes; adjust for alignment and tightening. (21' stands)
- RE 2 ▪ End and rear rails need replacement/upgrades to meet required* 4" gap code. (24' stands)
- AL 1 ▪ Aisle system with center handrails and 48" steps is needed for safety and will meet egress code. (24' stands)
- DC 1 ▪ Large row deck gaps need to meet required* existing bleacher 4" gap codes. (24' stands)
- SF 1 ▪ Check and tighten loose and missing exposed surface fasteners, replace as needed.
