# PROPERTY INSPECTION REPORT FOR:

**321 S. Bridge St.  
Manawa, WI 54949**

## **A CLOSER LOOK HOME INSPECTIONS, LLC**

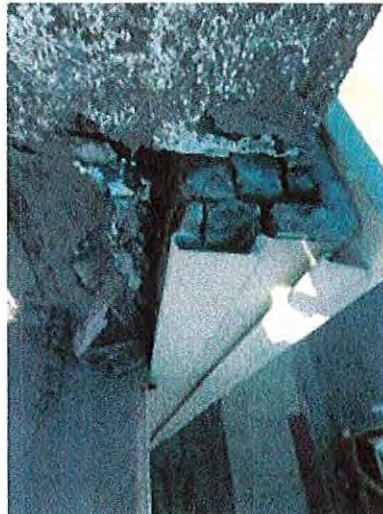
*FLASHING CONDITION:*

Repair is recommend, A licensed roofing contractor should be called to make further evaluation and repairs as needed.

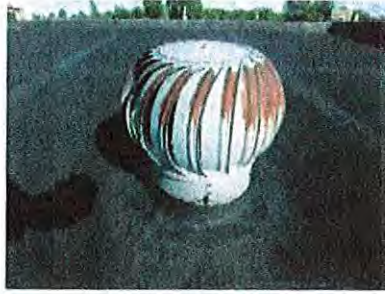
*VENTILATION SYSTEM:*

The ventilation system does not appear adequate for the size of the house. Recommend adding additional ventilation. Turbine.

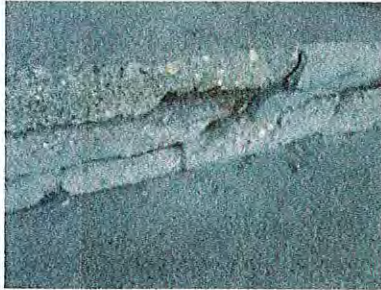
Recommend tuckpointing.

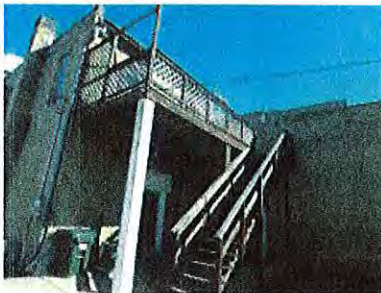
## DECKS

Handrails are loose. Recommend repair. Recommend installing handrails on steps. Some of the joist hangers are rusted through recommend replacement.

Handrails are loose. Recommend repair. Recommend installing handrails on steps.

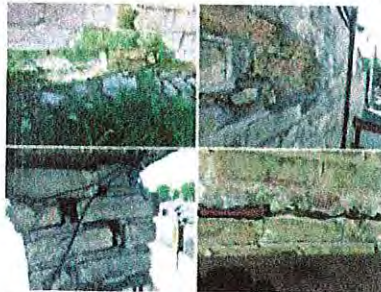
*SIDING CONDITION:*

Damaged Siding - Recommend Repair. Water is making its way behind brick. Recommend tuckpointing or rebuilding. A qualified contractor should be called to make further evaluation and repairs as needed.

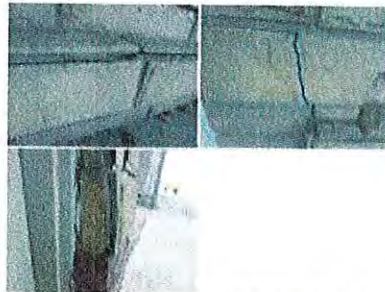
*TRIM CONDITION:*

Recommend painting/staining. Recommend caulking cracks.

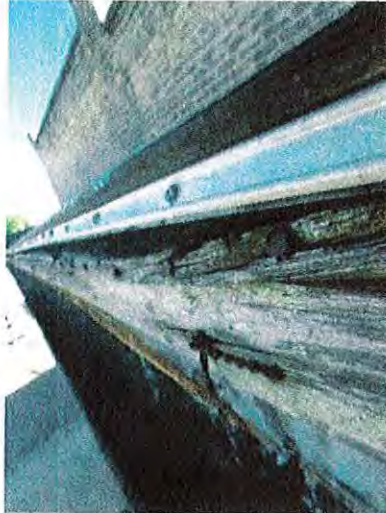
*SOFFIT AND FACIA CONDITION:* Damage noted - Recommend Repair, Some dry rot visible. Recommend repair.

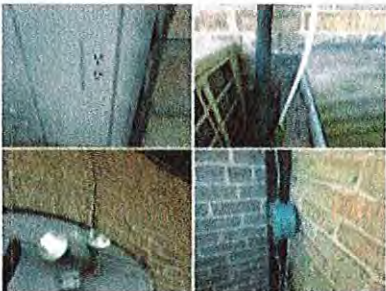
*SWITCHES/FIXTURES/OUTLETS  
:*

Non-Grounded outlet(s) present. Recommend grounding outlets. Exterior outlet missing waterproof cover (outlet on front of building), Cables inadequately attached or protected. Recommend properly securing.

Non-Grounded outlet(s) present. Recommend grounding outlets. Exterior outlet missing waterproof cover (outlet on front of building), Cables inadequately attached or protected. Recommend properly securing.

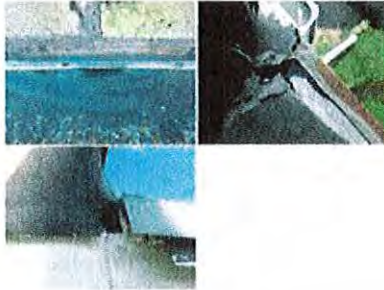
*GARAGE ROOF CONDITION;*

Corners on garage roof are unsealed and open, a licensed roofing contractor should be called to make further evaluation and repairs as needed. (recommend sealing)

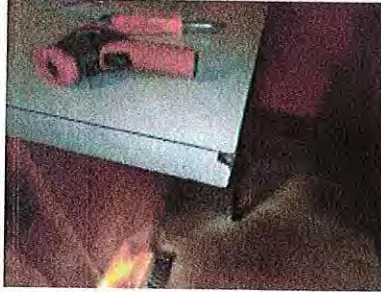
COUNTER TOPS:

Damage is noted.

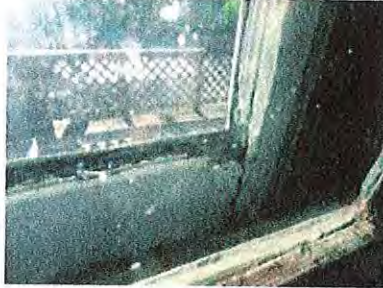
WINDOWS:

Dry rot noted on storm, Surface deterioration on window frames/sills. Doesn't want to sty up.

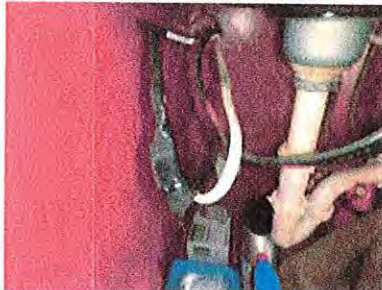
SWITCHES/FIXTURES/OUTLETS

Non-Grounded outlet(s) present. Recommend grounding outlets. **Electrical outlet(s) have reverse polarity. Recommend a licensed electrician repair.** Cables inadequately attached or protected. Recommend properly securing. **Open electrical splice(s). Recommend a licensed electrician repair.** (under sink)

Non-Grounded outlet(s) present. Recommend grounding outlets. **Electrical outlet(s) have reverse polarity. Recommend a licensed electrician repair.** Cables inadequately attached or protected. Recommend properly securing. **Open electrical splice(s). Recommend a licensed electrician repair.** (under sink)

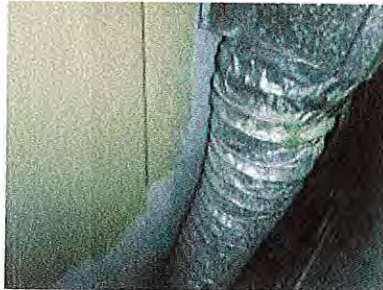
CLOTHES DRYER:

Vent that is currently being used for dryers is not approved for dryers, recommend replacement.

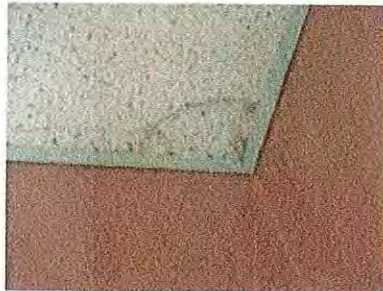
ADDITIONAL COMMENTS:

Door rubs needs adjustment. Surface deterioration on window frames/sills. Typical cracking noted in drywall, and moisture staining on ceiling.

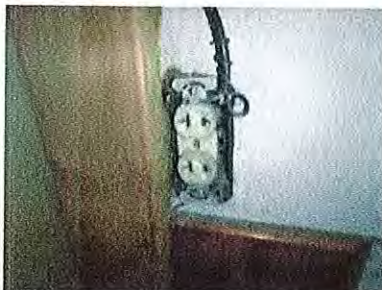
*SWITCHES/FIXTURES/OUTLETS* Electrical cover plate is missing. Recommend installing. And wiring is incorrect. (in hall closet)

**Electrical cover plate is missing. Recommend installing.** And wiring is incorrect. (in hall closet)

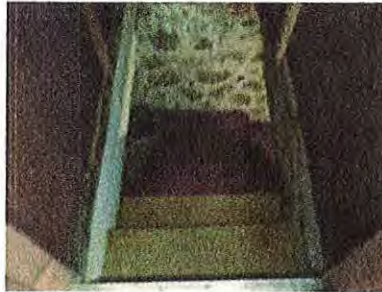
*STAIRS & HANDRAILS:*

No handrails are installed. Recommend installing. Door going to basement rubs.

No handrails are installed. Recommend installing.

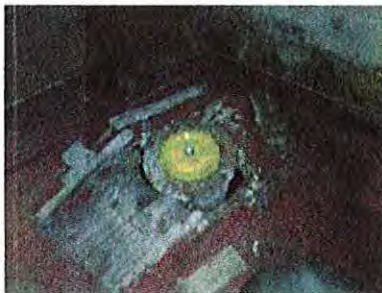
*FLOOR CONDITION:*

Recommend removing boards where toilet was and filling it in with concrete.

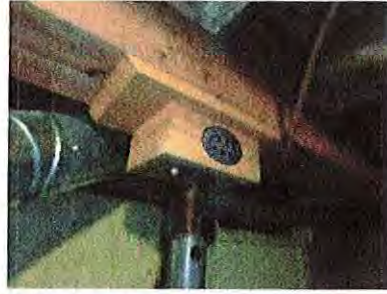
*BEAMS AND COLUMNS  
CONDITION:*

Post is not properly secured.

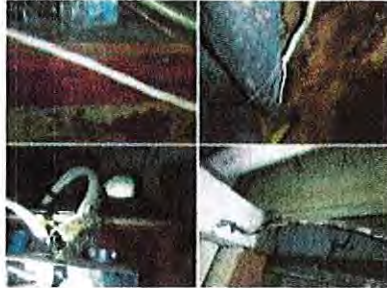
Cables inadequately attached or protected. Recommend properly securing. Some abandoned or disconnected wiring is found.

Cables inadequately attached or protected. Recommend properly securing. Some abandoned or disconnected wiring is found.

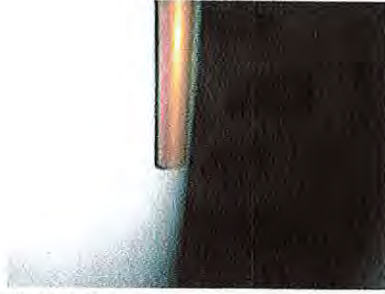
*CONDITION:*

Pressure relief valve drain pipe is missing or ends prematurely. Recommend installing.

**Pressure relief valve drain pipe is missing or ends prematurely. Recommend installing.**

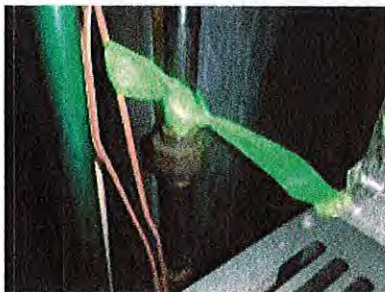
*FUEL CONDITION:*

**Gas Leak noted. Recommend a licensed heating contractor evaluate and repair as needed.**

**Gas Leak noted. Recommend a licensed heating contractor evaluate and repair as needed.**

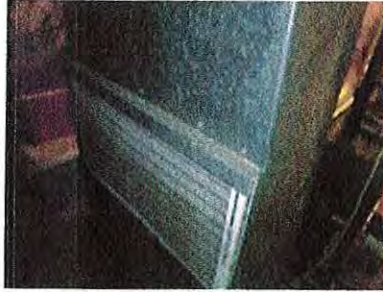
*COMBUSTION AIR:*

Vent installed in cold air return recommend removing and sealing.

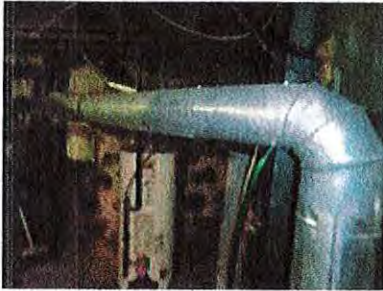
*VENTING:*

The vent pipe is not properly pitched . Recommended repair .

The vent pipe is not properly pitched . Recommended repair .

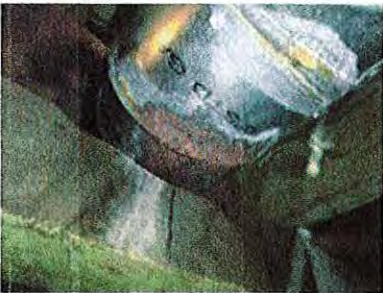
*DUCTS/AIR SUPPLY:*

Rust noted.

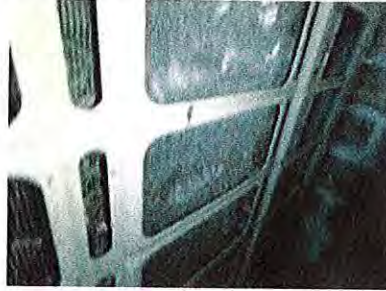
CONDITION: Damage/Deterioration noted, to compressor fins.

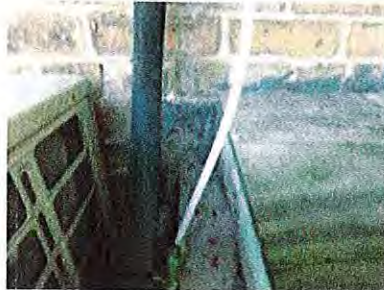
CONDITION: Cables inadequately attached or protected. Recommend properly securing. Unable to test, could not find remote.

Cables inadequately attached or protected. Recommend properly securing.

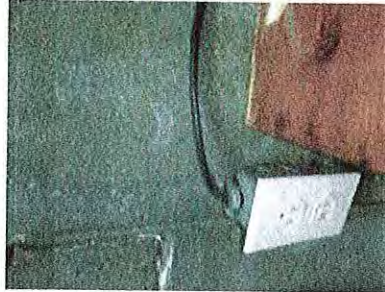
*Garage:*

Cables inadequately attached or protected. Recommend properly securing.
