Facilities Assessment Report

July 25, 2017

Introduction

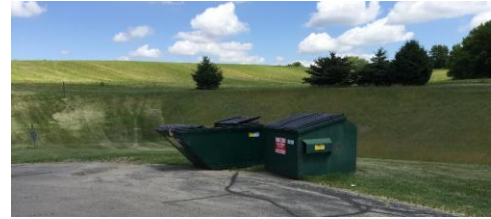
Trash / recycling dumpsters are unenclosed located on the service and access drive northeast of MES.

Enclose dumpsters at MES in a location accessible to both the building and refuse vehicles.

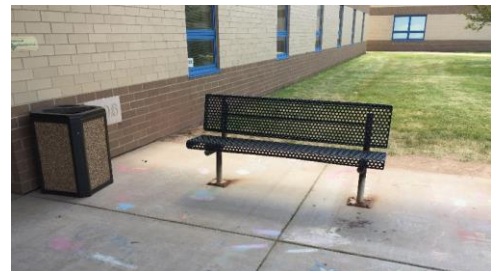
The bench supports at the main entry are deteriorating.

There are no bicycle racks.

Basketball hoops are a mixture of fixed and portable.

Rework site at MES main building entry to incorporate walkway edge protection landscaping, new benches or seating areas and bicycle rack locations.

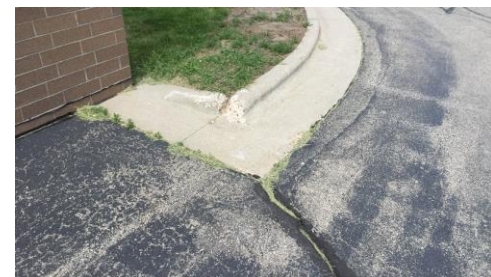
Pavement condition is poor. The district has noted the desire to resolve site circulation issues in conjunction with repairing pavement deterioration.

Walks at main entry allow foot traffic to destroy grass and landscaping adjacent to sidewalks.

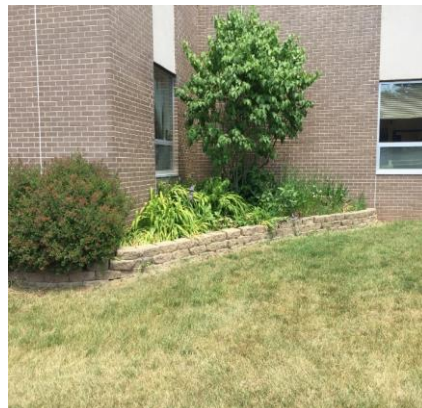
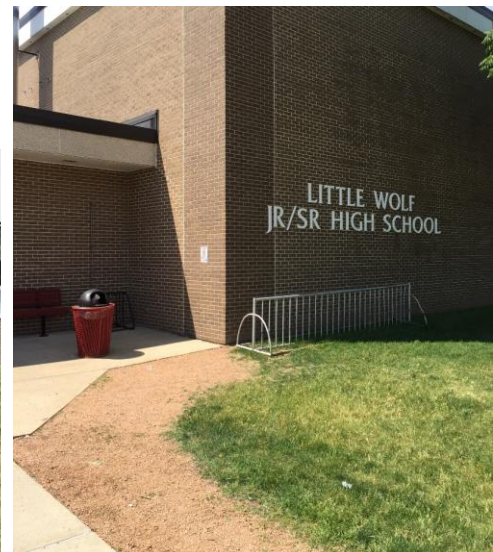
Bicycle rack locations are at multiple entrances. Bicycle racks at the main entry on the north side are in a location that is not easily accessible by a cyclist.

Plantings immediately adjacent to building are problematic for building exterior finishes. Vegetation does not allow the circulation of air and evaporation of moisture which will result in damage to the finish over an extended period.

3. Remove or relocate all vegetation adjacent to building structures.
4. Continue to monitor structure for any movement. Seal and protect any movement and cracking as it occurs.

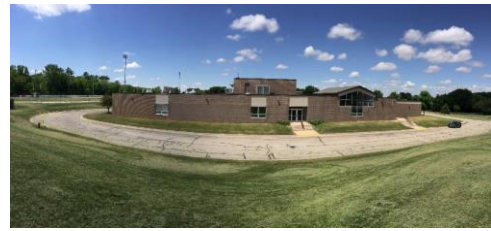
Asphalt pavement conditions are poor.

Grading and curbing at front (north) parking area have settled significantly and create very steep slopes.

The handicap accessible entrance and parking at the south side of the building adjacent to the kitchen area is not accessible. The slope at the parking space is steeper than the 1:48 allowed for the access aisle for the parking space. The approach to the entry door is also steeper than the 1:20 maximum slope allowed before the requirements of an accessible ramp need to be met. The slope is 3.7 degrees where only 2.86 degrees is allowed. There are no handrails and level landings as required.

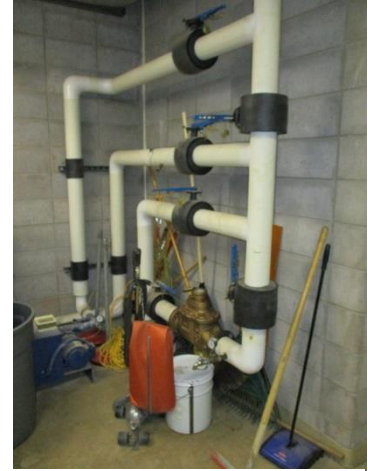
Photo: Main Water Service

The building is fed by a 6" water service with a 3" water meter. The domestic water piping is copper. There is no report by owner of problems with water piping or major leaks. Water pressure in the building appears to be in good working order. Copper supply lines should have 20 or more years of useful life.

The existing domestic piping can remain in place and is in fair to good condition. When piping approaching end of life expectancy, the domestic piping specialties, valves, and piping system should be scheduled for a replacement. Check isolation valves for any corrosion, and exercise semi-annually. Outdoor faucet hose bib should be checked periodically and tightened or replace packing as needed.

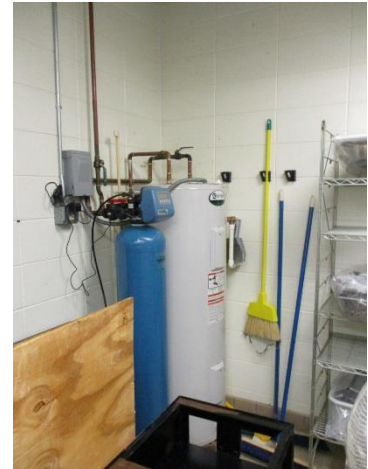
Photo: Kitchen Water Heater

There are four domestic water heaters serving the Elementary School. Two of the four water heaters are gas-fired and serve the north side of the school. These water heaters have a storage tank and recirculation pumps and are located on a mezzanine level in the mechanical space. These two units are A.O. Smith, atmospheric at 120 MBH each with 80% water heater efficiency. The third water heater is an electric A.O. Smith 50 gal with recirculating pump serving the south side of the school's classroom sinks and restrooms. The fourth water heater, located in kitchen storage area, is also an electric A.O. Smith 50 gal which serves the dishwasher equipment.

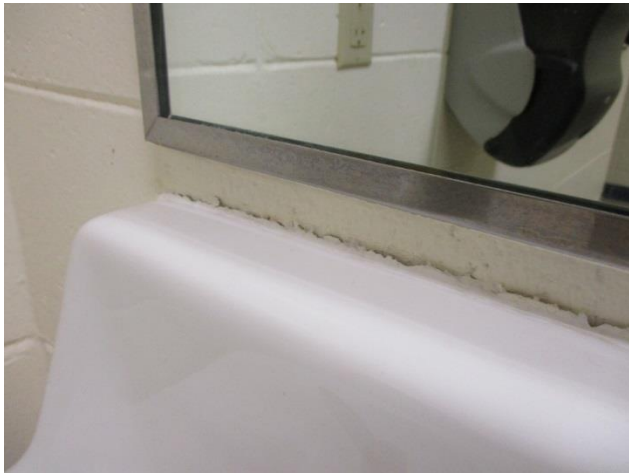
Photo: Recalk Fixtures

All faucet's aerator/screen should be removed, inspected for particulate accumulations, scrubbed clean, and reinstalled. If particulates are found, the aerator/screen should be periodically checked and cleaned. Recommend fixtures be re-caulked along the abutment to the attached wall.

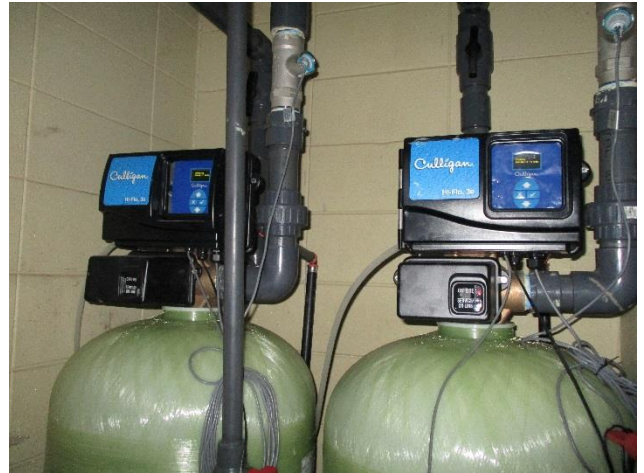
Photo: Water Softeners

There are two new water softeners serving the High School. Check isolation valves for any corrosion and exercise semi-annually.

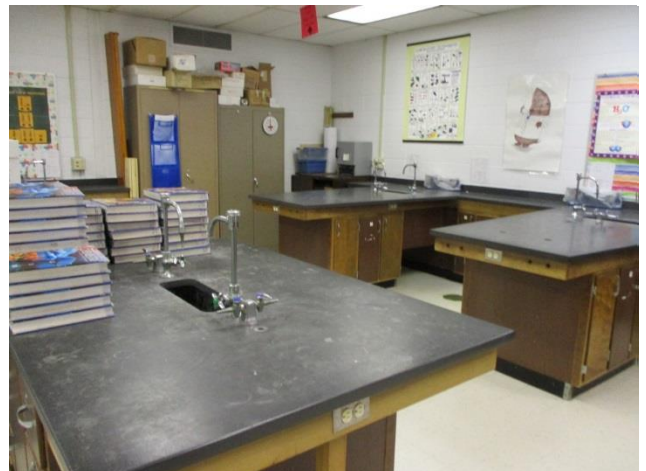
Photo: Science Lab Sink

For the science labs, the domestic water lines and gas piping are direct buried to extend from the wall to the island bench sinks. The existing gas and water piping below grade have potential for leaks based on age and corrosion of the piping system.

The existing domestic piping installed in 1968 and 1995 Additions can remain in place and is in reasonable condition. The piping is nearing its life expectancy, the domestic piping specialties, valves, and piping system should be scheduled for replacement. Gas piping to the science labs which have accessible isolation valves and emergency gas shut off switch to isolate system.

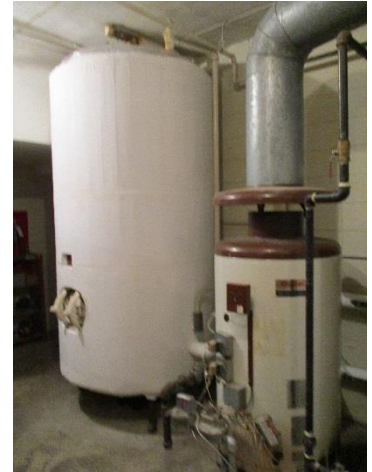
Photo: Main Water Heaters

There are three domestic gas-fired water heaters serving the High/Middle School. Two of the three water heaters are gas-fired which serves the High/Middle school. These water heaters has storage tank and recirculation pumps located in the basement mechanical space. These two units are A.O. Smith atmospheric at 670 MBH each with 80% water heater efficiency. The third water heater is gas-fired A.O. Smith 50 gal with 80% efficiency serving the kitchen area.

The gas-fired AO Smith water heaters are gravity vented through the roof. These water heaters are at their end of useful life and need to be replaced immediately to avoid long term outage with hot water system.

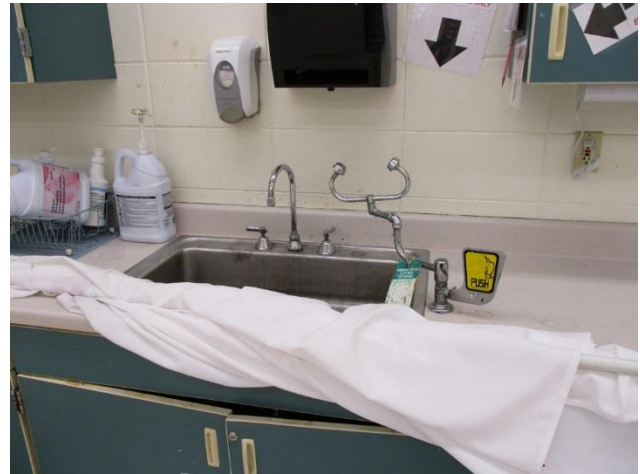
Photo: Art Room Sink - Eye Wash

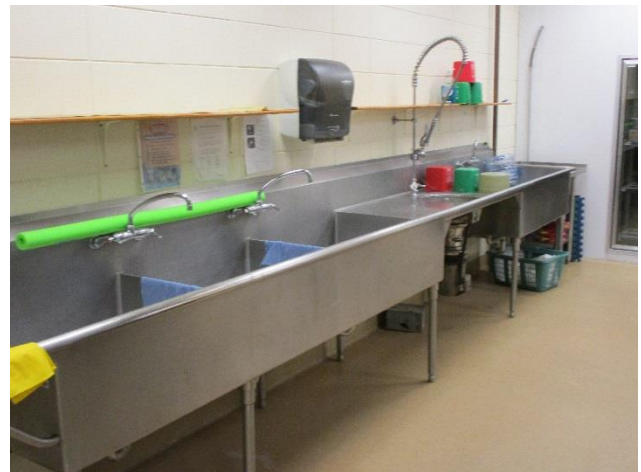
Photo: Three Compartment Sink

The existing domestic piping can remain in place. Provide annual maintenance of grease interceptor. We recommend the sewers below finished floor be inspected with a camera to determine the actual condition. The fire extinguishers and kitchen hood suppression system should be inspected on monthly bases thorough examination and if repair or replaced as needed. Annual maintenance is also required to be recorded on a tag or label attached to each extinguisher. Grease hood filters/baffle should be cleaned regularly. Existing grease duct should be cleaned based on frequency and use of hood.

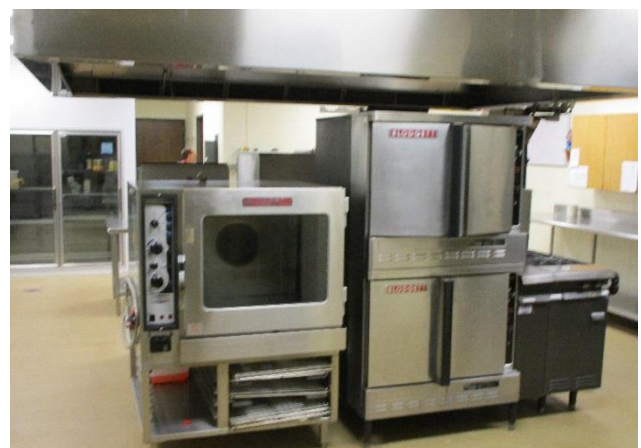
The kitchen equipment appears to be in good working condition includes 9'x8' canopy hood, three compartment sink, pot wash sink and disposal, dishwasher, gas range and free standing cooler/freezer.

Photo: Kitchen Hood

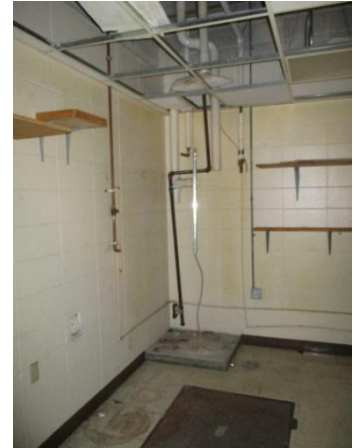
The main plumbing service for this building has been unused for an extended period due to the building being unoccupied. The plumbing systems within the building have been partially to fully removed or damaged by a previous demolition/salvage contractor or vandalism situations for the unoccupied structure. The plumbing fixtures remaining have been in an unoccupied building over the years, are not maintained, and are in poor condition. The restrooms are not ADA compliant and all the remaining fixtures don't meet current code requirements. It is recommended that if the building is to become occupied that all plumbing fixtures and systems be replaced. There is some value (copper piping) remaining in place and may hold some salvage value. All of the water heaters installed in 1983 have been removed.

Photo: Water Heater Removed

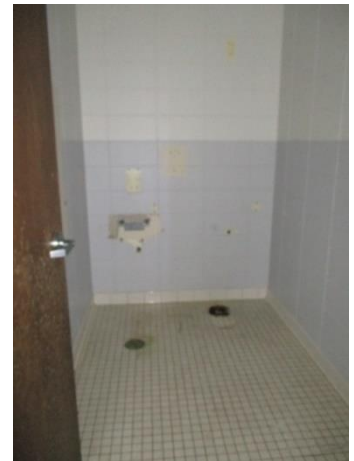
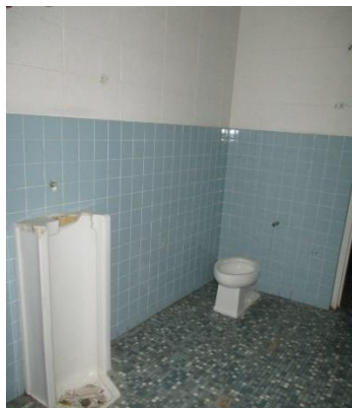
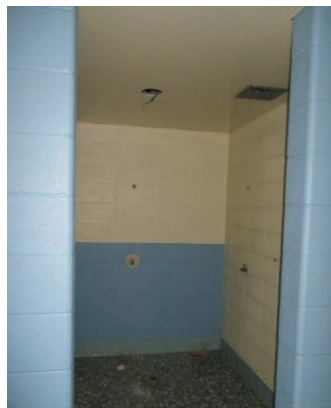
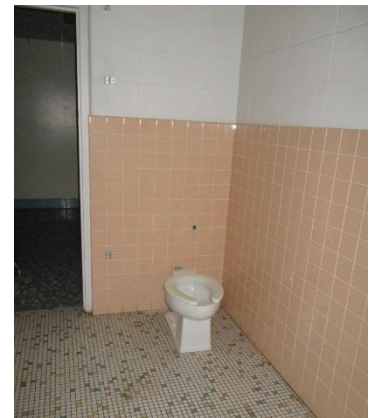
Photo: Fixtures Removed

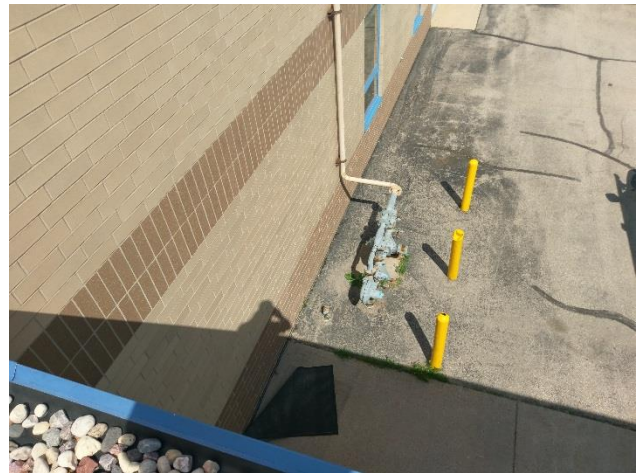
Photo: Gas Meter - Aerial View

The gas meter service and equipment are in good condition and can remain. There is adequate capacity to accommodate any future building additions or renovations.

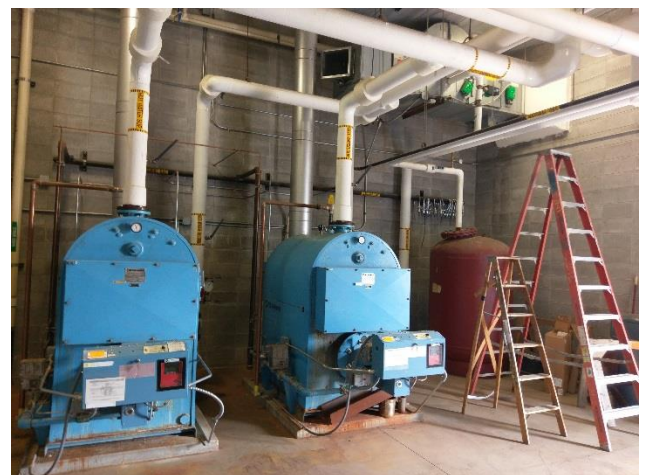
The existing boiler plant consists of two Kewanee model K-4 hot water, forced draft boilers with separated combustion. Combustion air is provided by space air handling unit AHU-6. Each boiler heating capacity is 2,000 MBH. The boilers are fired with natural gas. These boilers are original, 22 years old, with a heat plant efficiency of 75%. Currently, one boiler handles majority of the heating load of the building until outdoor temperature drops to 10 °F, at which point both boilers operate. The boiler pumps circulate hot water through a primary-secondary pumping system that supplies hot water to the building air handling units' heating coils, unit heaters, cabinet unit heaters, etc. The owner noted that only one of the two boilers currently operates which struggles to remain on due to the loss of ignition.

Photo: Hot Water Boilers

The hot water boilers have been maintained over the years. However, these particular boilers are at the end of their useful life. One of two boilers is not functioning while the other has difficulty staying on. It is recommended that both boilers be replaced with high efficiency condensing boilers (minimum of three) sized at 40% capacity. New high efficiency boilers are recommended to have integrated controls and alarms with a Building Automation System (BAS). The breeching stacks also need to be modified. If boilers and domestic hot water heaters are to be replaced with condensing appliances, the existing combustion air handling unit AHU-6 should be removed at same time.

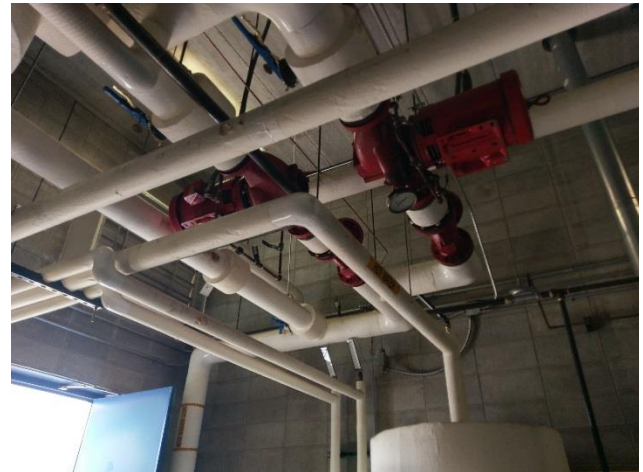
There are two hot water pumps in a constant speed or constant volume (CV) application. Only one of two hot water pumps operate while the other pump is on standby. These secondary hydronic pumps distribute hot water from the boilers to the building.

The hot water supply and return piping is insulated. The existing valves and other hot water specialties also appear to be in good working condition.

Photos: Hot Water – Secondary Pumps

The hydronic pumps for the primary-secondary pumping system are nearing the end of their useful life. It is recommended that the primary circulating pumps be replaced along with the boilers. The secondary circulating pumps are in average condition based on age of the equipment. As a facility improvement measure, the secondary circulating pumps could be replaced with variable speed pumps with VFD drives and piping loop differential pressure sensor. Pumps should be sized for 60% capacity for lead-lag automatic operation. All the pump's piping specialties to be replaced along with the pumps.

The main 4" hot water supply and return distribution piping from the boiler plant appears to be in good condition. The existing hot water piping can remain in place and is in fair to good condition. When piping approaches the end of its life expectancy, the hot water piping specialties, valves, and piping system should be scheduled for a replacement.

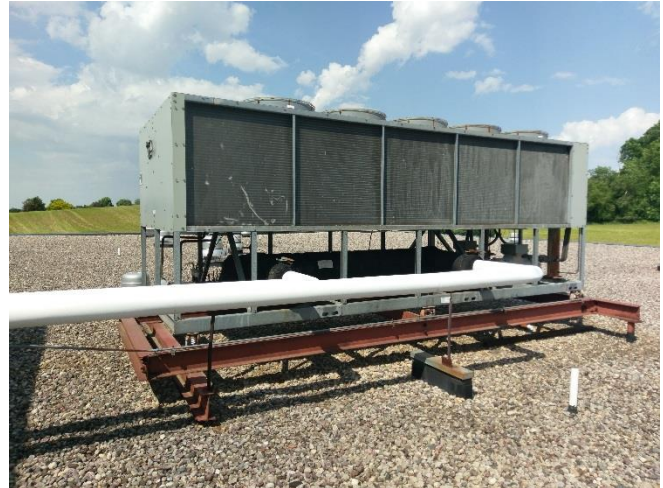
The existing chiller plant consists of a rooftop Trane model, Series R, air-cooled chiller with two helical rotary compressors and two circuits at a nominal 120 Ton capacity. This chiller has an EER of 9.6 with good linear part-loading. The unit has eight condenser fans at IPLV 12.6. This outdoor air-cooled chiller is original, which is 22 years old. The refrigerant type is R-22, which is being phased out over time. As of 2016, R-134a, R-410A, and R-407C began phasing-out as well. The unit has low ambient lockout. The chilled water temperature set point is 45° F and has a reset temperature feature based on return water or outdoor air temperature.

Photo: Air-Cooled Chiller

The condition of the air-cooled chiller is average based on the age of the equipment. The Trane chiller compressor is robust and can likely be maintained for another 5 to 7 years, unless a refrigerant leak occurs in the system. It is recommended to continue with preventative maintenance by monitoring, tracking, and repairing any leaks to the system. The new equipment efficiencies for air-cooled chillers are marginal for the number of run-time hours being served. New refrigerants are forthcoming in the next two to three years when R-22 will no longer be produced or imported. HCFCs will also begin being phased out over the next ten years. It's important that the existing chiller is working properly and maintains peak efficiency.

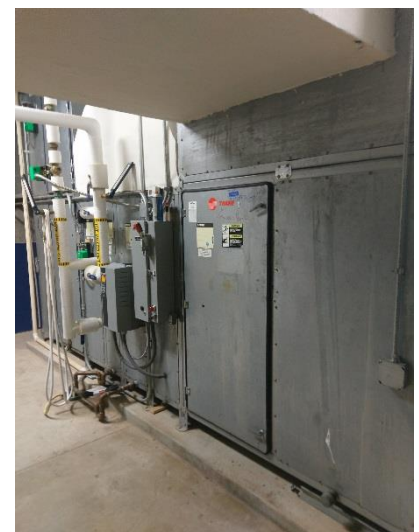
Air Handling Units

Air-conditioning and ventilation is provided through a combination of indoor air handling units located in the two mechanical penthouses. A total of six (6) indoor air handling units (AHU) were furnished and installed with the 1995 original building. Units are Trane M-series as manufactured with double wall construction. These units are still in service.

The six (6) AHU's installed were constant volume (CV), reheat systems. In 2009, most of these air handling units were converted to variable air volume (VAV) system with VFD drives. This type of system provides a variable volume airflow quantity with a temperature between 55 and 60 degrees F. Space zoning is accomplished with air terminals while final heating is provided through duct mounted heating coils with limited areas containing perimeter radiant heating.

The existing indoor air handling units AHU-1 through 5 can remain in place and are in fairly good condition. Provide annual maintenance of all air handling unit filters, coils and fan wheels/belts. It's recommended that the fan belts be aligned and fan bearings be greased. Existing supply ductwork contains debris and should be inspected and cleaned. Ductwork is insulated and appears appropriate. The existing control valves to coils and other water specialties also appear in good working condition.

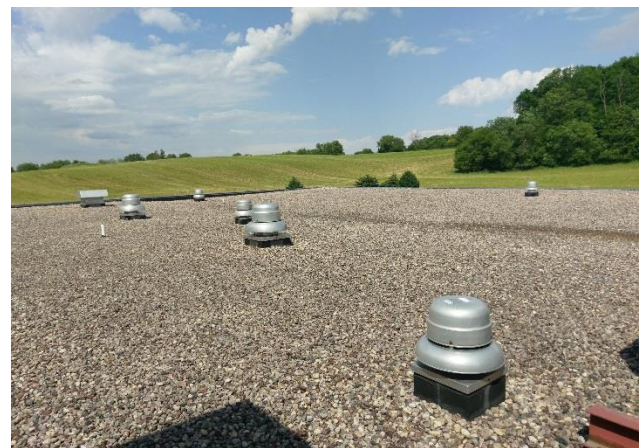
There are a number of exhaust fans serving spaces in the Elementary School. Most of the exhaust fans are of aluminum construction and reside outdoors on the roof. Fan powered units are belt driven manufactured by Penn-Barry. A total of sixteen (16) outdoor power roof ventilators (PRV) serving a number of space functions such as restrooms, locker rooms, kitchen, dishwasher, janitorial, and receiving area were all furnished and installed with the 1995 original building. These units are still in service with the exception of PRV-8, 10, 14, 15, and 16 which originally served spaces such as

Photo: Powered Roof Exhaust Fans

The existing outdoor exhaust fans can remain in place and are in reasonably good condition. It's recommend fan belts and bearings be checked for excessive noise, vibration or wear. It is recommended these exhaust fans be replaced with direct drive with ECM motor as a part of facility improvement measure for increased efficiency and reduced maintenance costs.

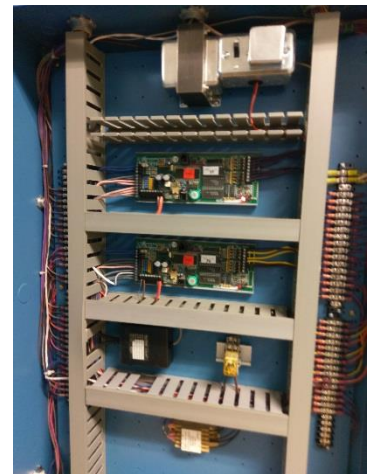
The building temperature controls are Direct Digital Controls (DDC) with electric actuation. The original DDC controls were KMC Control devices on a network system. Overall network and DDC system serving the existing air handlers units and pump systems are obsolete. Controllers cannot be repaired or replaced with available parts. The current DDC system with electronic control is over 20 years old, which exceeds its expected life span and calibration.

Photo: Direct Digital Controls (DDC)

The building temperature controls should be upgraded to Direct Digital Control (DDC) as part of any future building renovation or upgrade. A temperature controls upgrade to DDC would provide a fully automated system, complete with software and graphics. Monitoring and adjustment of building systems and zone set points would be available through an operator workstation.

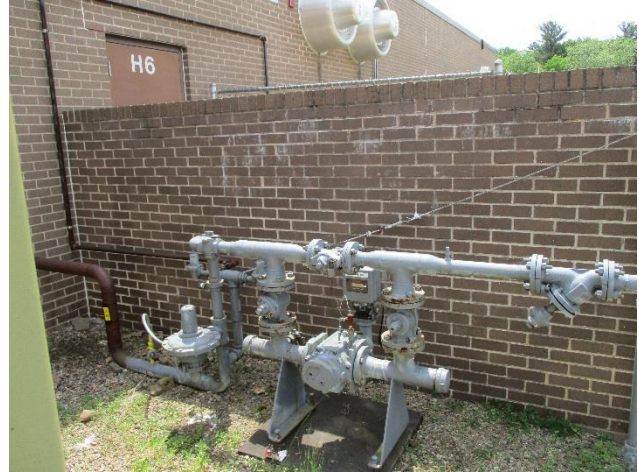
The facility is served by an Alliant Energy gas meter located at the east end of the building adjacent to the brick screen wall. The 3" natural gas service line at 2 psig is provided from the local utility company. This line extends into the High School ceiling area above locker rooms and ties into the existing main gas line in basement. The gas services feed the 1995 Addition hot water boilers, 2014 gas-fired rooftop units, domestic water heaters in the basement and kitchen range appliances.

Photo: Main Gas Meter

The gas meter service and equipment are in good condition and can remain. There is adequate capacity to accommodate any future building additions or renovations.

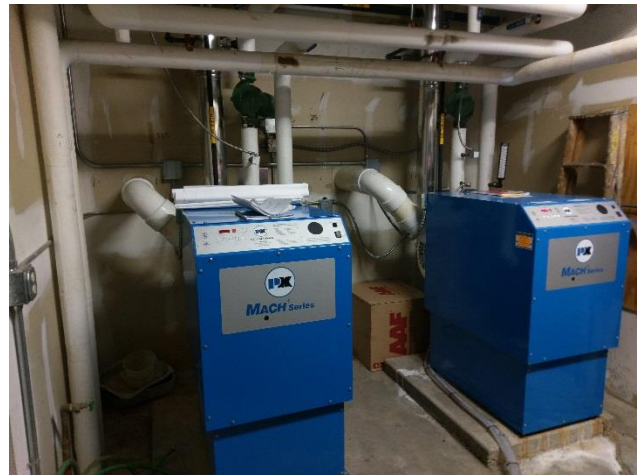
Currently in the 1995 Addition, there are two high efficient condensing boiler serving the west and east ends of the High School. Each boiler's heating capacity is 450 MBH. The boilers are natural gas fired. These boilers were installed in 2008, making them 9 years old with a heating plant efficiency of 92%. The boilers circulate hot water through a primary-secondary pumping system which supplies to the building's VAV reheat coils, booster coils, perimeter radiation, cabinet unit heaters, etc.

Photo: Hot Water Boilers

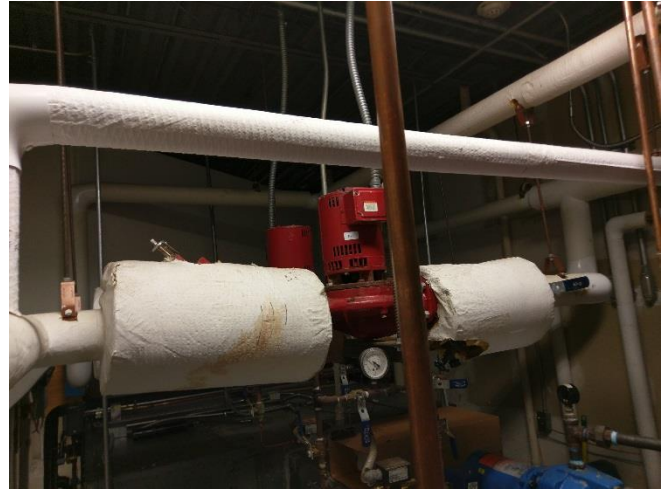
There are two (2) hot water pumping loop systems with individual dual constant speed or constant volume (CV) application. Only one of the two hot water pumps operate while the other pump is on standby. These secondary hydronic pumps distribute hot water from the boilers to the building.

The hot water supply and return piping is insulated. The existing valves and other hot water specialties also appear to be in good working condition.

Photo: One Pair of Hot Water Pumps

The hydronic pumps for the primary-secondary pumping system are nearing the end of their useful life. It is recommended that the primary circulating pumps be replaced. The secondary circulating pumps are in average condition based on age of the equipment. As a facility improvement measure, the secondary system could be replaced with variable speed pumps with VFD drives and piping loop differential pressure sensor. Pumps should be sized for 60% capacity for lead-lag automatic operation. All of the pump's piping specialties should be replaced with the pumps.

The 4" mains and 2" branch hot water supply and return distribution piping from the boilers appears to be in good condition. The existing hot water piping can remain in place and is in good condition. When piping approaches the end of its life expectancy, the hot water piping specialties, valves, and piping system should be scheduled for a replacement.

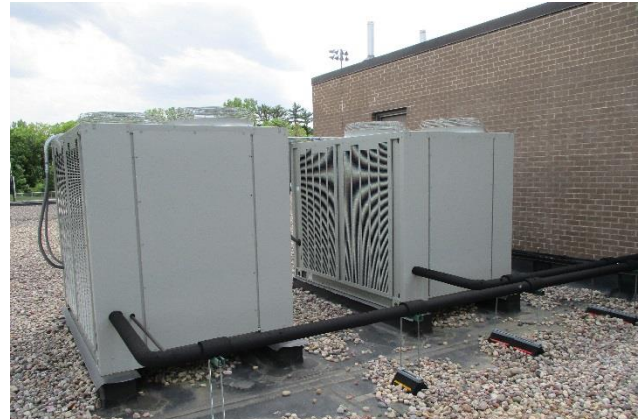
The existing installed DX chiller plant consists of an air-cooled condensing DX refrigerant, rooftop Trane model, with two scroll compressors and two circuits at a nominal 30 Ton capacity. This scroll condensing unit has an EER of 11.2 with good part-loading and three condenser fans at IPLV 16.2. The original outdoor air-cooled chillers were installed in 1995, but these units look like they have been recently replaced with 2014 rooftop equipment units. The refrigerant type is R-410A.

Photo: Air-Cooled Condensing Units

The condition of the air-cooled DX condensing unit is good based on the age of the equipment. The Trane scroll compressor is robust and can likely be maintained for another 10 to 15 years, unless a refrigerant leak occurs in the system. It is recommended to continue with preventative maintenance by monitoring, tracking, and repairing any leaks to the system. It's important the existing condensing unit is working properly and maintains peak efficiency.

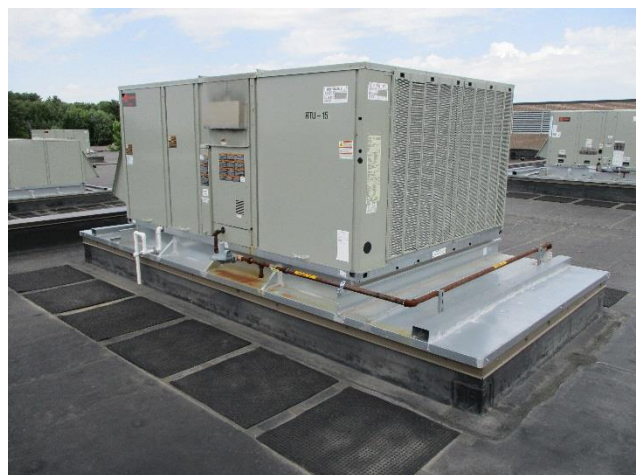
There are seventeen (17) rooftop units serving the original High School. These units are gas-fired with DX cooling with relief air. The cooling capacity ranges from 12-1/2 - 20 Tons. In 2014, all the rooftop units were replaced as a facility improvement measure. Trane Voyager is rated at an EER of 12. All units have new controls and thermostats serving the associated classrooms and support spaces.

Photo: Gas-fired Rooftop DX Units

The existing rooftop units are in good condition and can remain in place. Continue with preventative maintenance and operation of the rooftop units. Replace belts and filters annually.

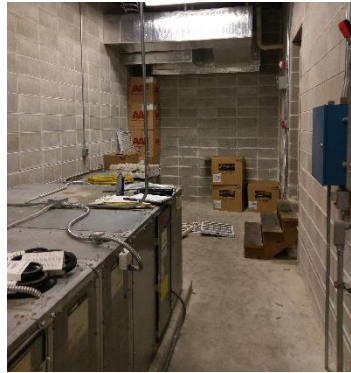
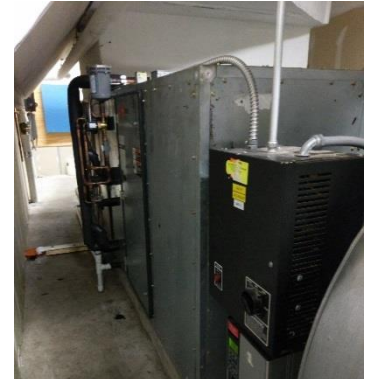
There are three indoor air handling DX units serving the 1995 Additions. Two air handling units serve the west end classrooms, with a cooling capacity of 25 Ton each. The other air handling unit is located on the east end serving the lockers. Outdoor condensing units were replaced in 2014.

Photo: Indoor AHU DX Unit Photo: Indoor AHU DX Unit

The existing indoor units are in good condition and can remain in place. Continue with preventative maintenance and operation of the indoor units. Replace belts and filters annually.

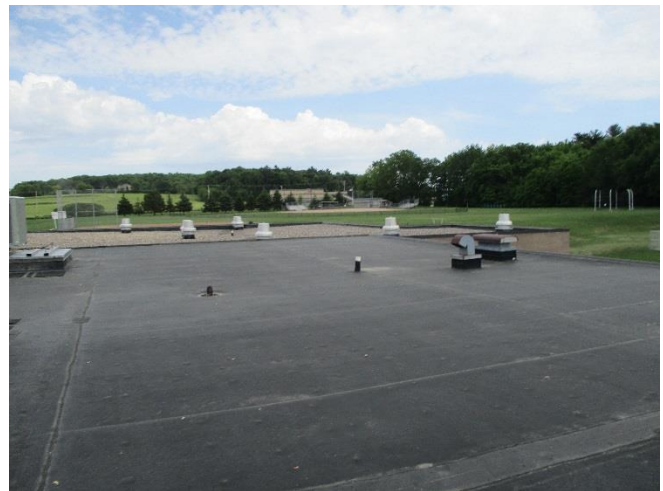
There are a number of rooftop exhaust fans serving spaces in the High School. Most of the exhaust fans are of aluminum construction. These fan powered units are belt driven, manufactured by Penn-Barry. A total of nine (9) outdoor power roof ventilators (PRV) and seven (7) sidewall exhausters on the 1995 Addition serving a number of space functions such as restrooms, locker rooms, kitchen, dishwasher, janitorial, recycling & receiving, storage areas, dark room, kiln, stain glass, and Art Dept. general exhaust were all furnished and installed with the 1995 Additions to the building.

Photo: Power Roof Exhaust Fans

The existing outdoor exhaust fans can remain in place and are in reasonably good condition. It's recommended that fan belts and bearings be checked for excessive noise, vibration or wear. It is also recommended these exhaust fans be replaced with direct drive with ECM motor as a facility improvement measure for improved efficiency and reduced maintenance costs.

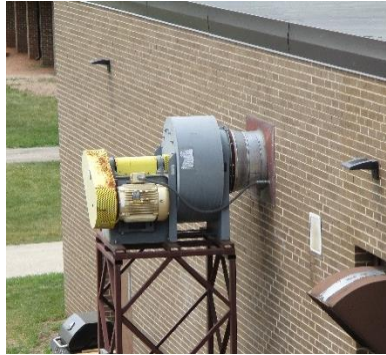
There is an outdoor dust collector system with a centrifugal type separator with an airflow of 1,385 cfm serving the shop area. This unit is quite worn and at the end of its useful life. Also similar condition applies to the adjacent shops and their exhaust fans.

Photo: Shop Exhaust Fan

The existing duct collector can remain in place, but is in poor condition. It's recommended that fan belts and bearings be checked for excessive noise, vibration or wear.

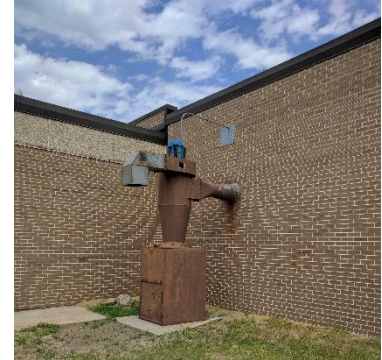
Photo: Dust Collector

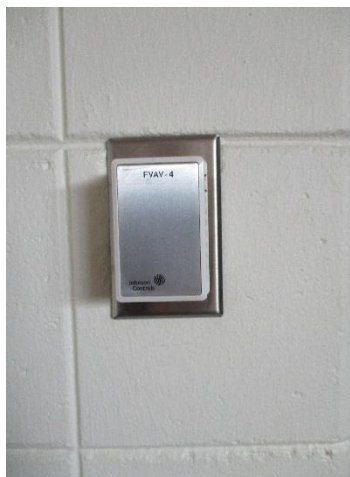
The building temperature controls are Direct Digital Controls (DDC) with electric actuation. The original controls were upgraded recently to Trane Control devices with the 2014 roof equipment replacement project. Overall network DDC controllers serve the existing rooftop air handlers and unitary equipment. There are some JCI controllers and devices which serve the 1995 Addition. JCI controllers are over 22 years and are obsolete controls.

Photo: Johnson Controls Thermostats

The building temperature controls should be upgraded to Direct Digital Control (DDC) as part of any future building renovation or facility improvement measure. It is recommended that the temperature controls be upgraded to new DDC controller with a fully automated system, complete with software and graphics. Monitoring and adjustment of building systems and zone set points should be available through an operator workstation.

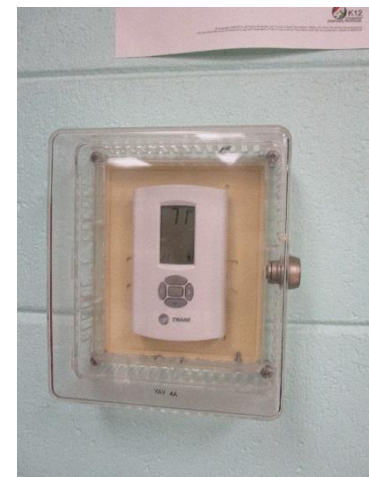
Photo: Trane Controls - Thermostat

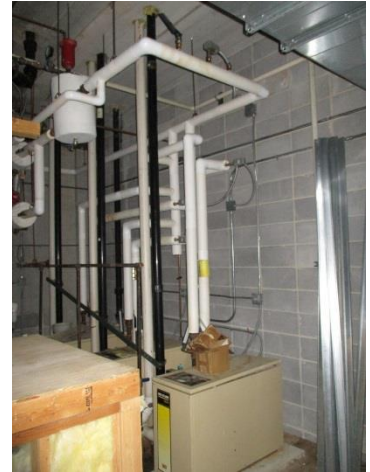
The existing hot water boilers reside on the mezzanine level with the associated inline hydronic pumps. There are two Weil McLain GV, sealed combustion hot water boilers, with less than 150 MBH each with their associated pumps. All boilers are gas-fired which are subject to a recall for a gas valve concern. The heating systems are abandoned with no power, and have not been operational for an extended period of time. There is some salvage value (copper piping) that remains in place. The existing equipment and piping specialties have no salvage value. Electric wall mounted unit heaters at each vestibule are not salvable. It is recommended that if building is to become occupied that all boilers and piping be replaced.

Photo: Hot Water Boilers

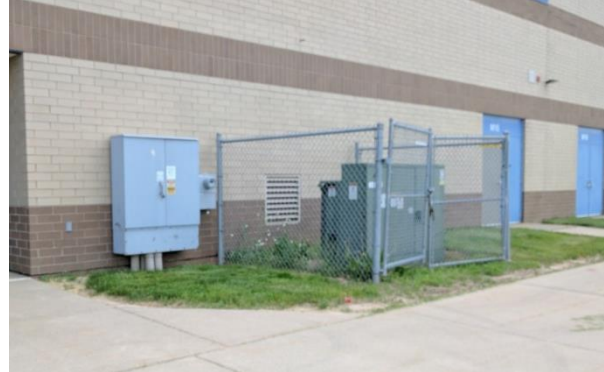
The facility is served by Alliant Energy via a pad mounted transformer located within a chain link fence off the north end of the building. The service lateral travels underground from the transformer to a wall mounted current transformer cabinet and then back underground, and up into the bottom of the main switchboard.

Photo: Service Equipment

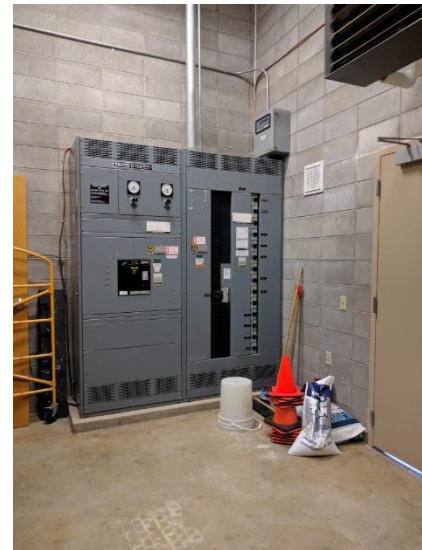
The main switchboard is 1600A, 480Y/277V, 3-phase, 4-wire, Square D QED-2 and is in good condition. It contains a main circuit breaker with shunt trip power and ground fault sensor. The switchboard contains a double row branch distribution sections with feeder breakers to serve downstream loads. There is capacity to add additional breakers within this section.

Photo: Main Switchboard

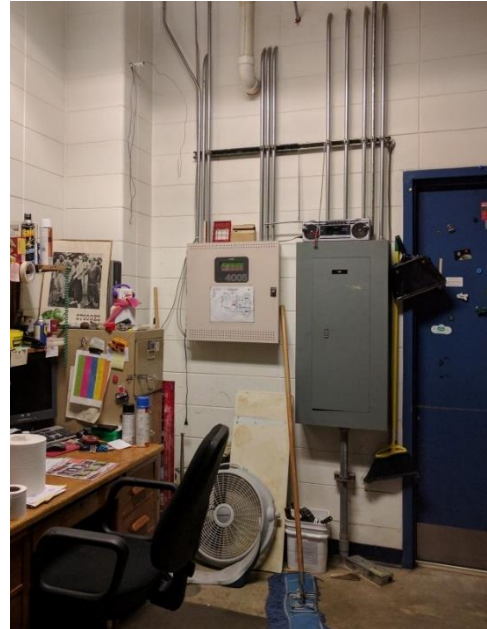
Photo: Fire Alarm Control Panel

Replace the fire alarm system entirely with a new system that is speaker based and provide full intelligibility as required by 2015 International Building Code article 907.2.3. Consider providing full area detection coverage, unless a fire sprinkler system is provided.

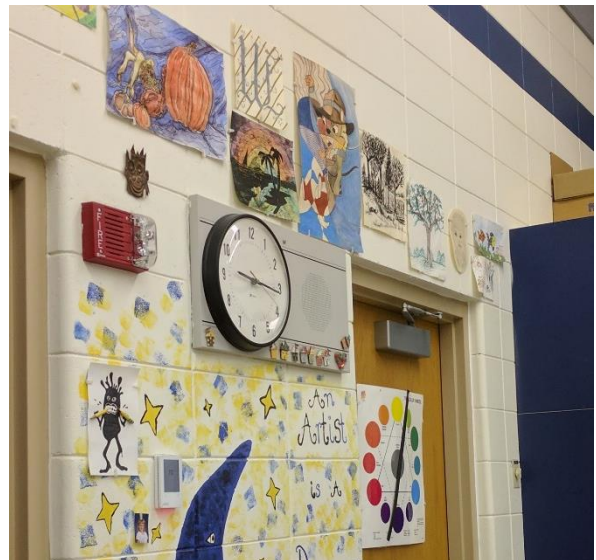
Photo: Typical Classroom Clock/PA

Replace the existing clock system with wireless GPS technology type system. This will ensure that all occupants within the building are seeing the same time.

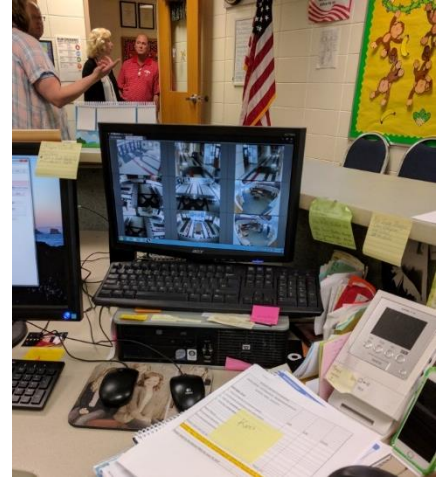
There is an IP camera based video surveillance system located throughout the building. Cameras are located in the corridors, building entrances, library and cafeteria. All cameras are manufactured by Axis. There is a live view monitor located in the main office. Video surveillance head end equipment is located in MDF room and can accommodate additional cameras.

Photo: CCTV Monitor

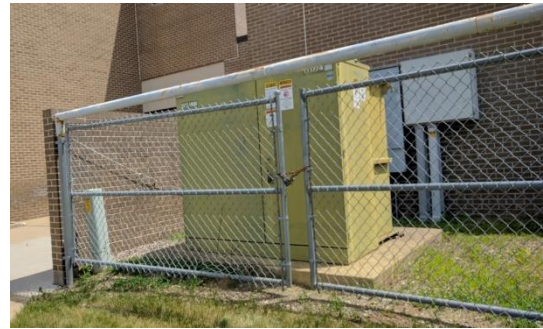
The facility is served by Alliant Energy via a pad mounted transformer located within a chain link fence off the west end of the building. The service lateral travels underground from the transformer to a wall mounted current transformer cabinet and then back underground, through the basement, to the building's main switchboard located in the main electrical room.

Photo: Alliant Energy Transformer

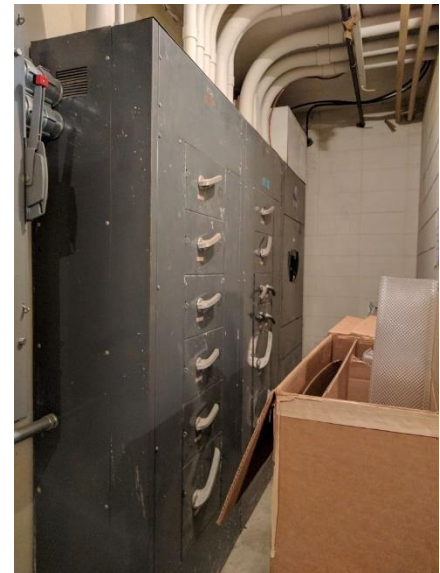
The main switchboard is 1600A, 480Y/277V, 3-phase, 4-wire, manufactured by I-T-E and has a manufacture date of 9/17/69. It contains a main, fused switch, with shunt trip power and ground fault sensor. The switchboard contains two distribution sections with branch fused switches to serve downstream loads. There are no spaces or unused switches within the distribution sections.

Per Wisconsin SPS 316.230, *“Raceways containing service conductors or cables, or service entrance cable not contained within a raceway, may not extend longer than 8 feet into a building to the service disconnect or the first service disconnect of a group of disconnects as permitted by NEC 230.71. The raceways or conductors shall be considered to have entered the building at the point where they pass through the outer surface of the building exterior, except as permitted by NEC 230.6.”* As a result, the

Photo: Main Switchboard

replacement of this switchboard is going to require the service to meet current codes. This can be done a number of different ways, including the addition of a service disconnect on the exterior of the building, concrete encasement of the existing service feeder within the building, or relocation of the service equipment to limit the service conductor length within the building to no longer than 8 feet.

Replace existing switchboard that this antiquated and filled to capacity. New and replacement parts for this switchboard are going to become exceedingly hard to find when needed and any switchboard failure will likely result in an extended outage.

It is recommended that surge suppression be added to the main incoming service.

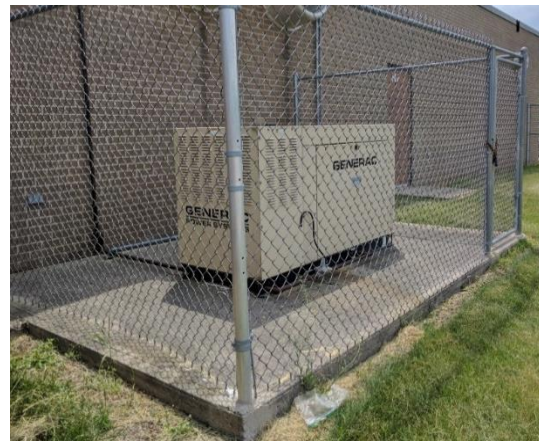
The emergency systems are served by a Generac exterior emergency generator fueled by natural gas. The generator is located within a chain link fence off the west end of the building, directly south of the utility transformer. The generator appears to be approximately 20 years old and installed under the 1995 addition project or shortly thereafter. It appears to be in good condition

Photo: Exterior Generator

The generator appears to be in good condition, although it is nearing its life expectancy. It is recommended that it be replaced within the next five years or that it be replaced during any significant building renovations or additions. The existing generator fed loads are part of NEC 700 (emergency) and NEC 701 (legally required) branches of power. Per NEC 700.10(B) these branches of power are required to be segregated which will require the addition of a transfer switch and panelboard so that the 701 loads can be removed from the 700 branch of power. In addition, all downstream branch wiring requires segregation from each other, as well as from the normal power branch wiring. It is recommended that this branch wiring be re-done in new 700 and 701 dedicated raceways.

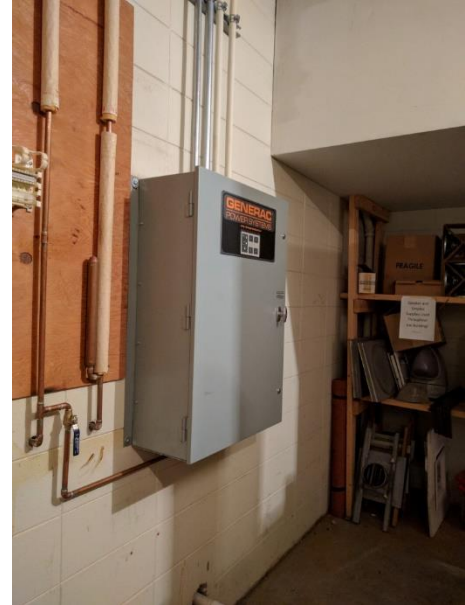
The emergency feeder travels from the generator into an automatic transfer switch located in the basement main electrical room. The transfer switch 208/120V, 3-phase, 4-wire, 100A and is a Generac HTS type. It appears to have been installed within the last ten years and is in good condition.

Photo: Automatic Transfer Switch

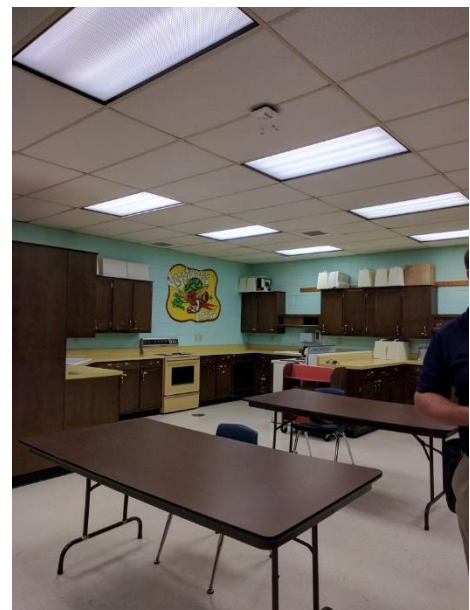
Photo: Typical Classroom Lighting

Provide increased lighting controls in classrooms, library and office areas to allow occupants to reduce lighting levels depending on tasks being performed. Areas that contain monitors or projectors are recommended to have fixtures that wash the projection screens or monitors controlled separately so they can be turned off during presentations to maximize visibility of images/videos being displayed.

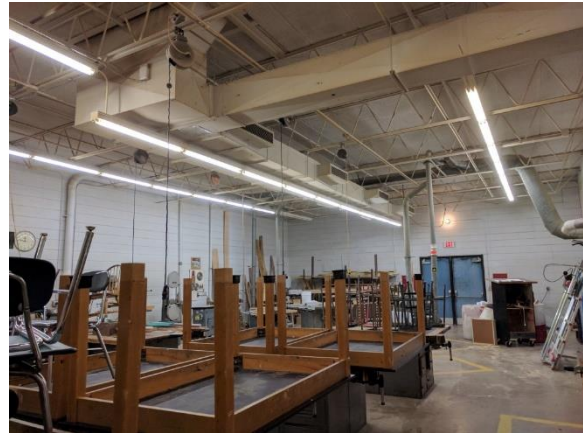
Photo: Typical Shop Area Lighting

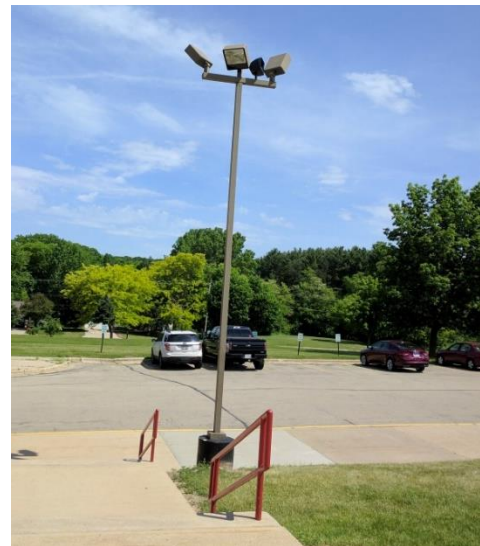
Photo: Exterior Pole Lighting

Replace exterior metal halide fixtures with more energy efficient LED type fixtures. It's recommended that new fixtures be dark sky compliant to reduce the existing light pollution in the sky, and also ensure that light energy reaches the intended surfaces and is not wasted.

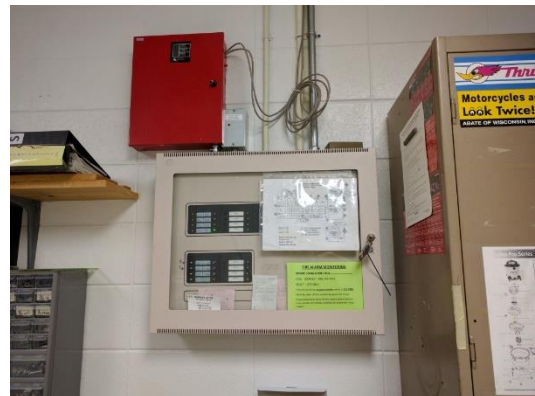
The existing system is a Simplex 4002, zoned system with visual and horn based audible notification. There are a few scattered smoke detectors located throughout the building, as well as duct mounted smoke detectors within air handling unit ductwork for alarm initiation. In addition, there are pull stations located near each egress door at 60" AFF.

Notification devices are located in corridors and some larger rooms including the library and shop spaces. However, strobe coverage is inadequate for the spaces covered.

Photo: Fire Alarm Control Panel

Replace the fire alarm system entirely with a new system that is speaker based and provide full intelligibility as required by 2015 International Building Code article 907.2.3. Consider providing full area detection coverage, unless a fire sprinkler system is provided.

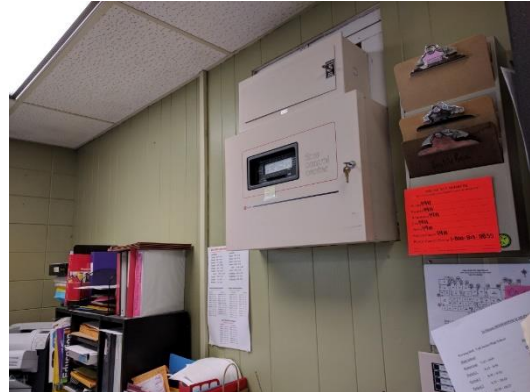
There is an existing Simplex Time Control Center installed in the main office that is still in use. Many of the Simplex clocks located throughout the building have been replaced with stand-alone, battery powered clocks that are not tied into the central Simplex system. None of these clocks are synchronized.

Photo: Time Control Center

Replace the existing clock system with wireless GPS technology type system. This will ensure that all occupants within the building are seeing the same time.

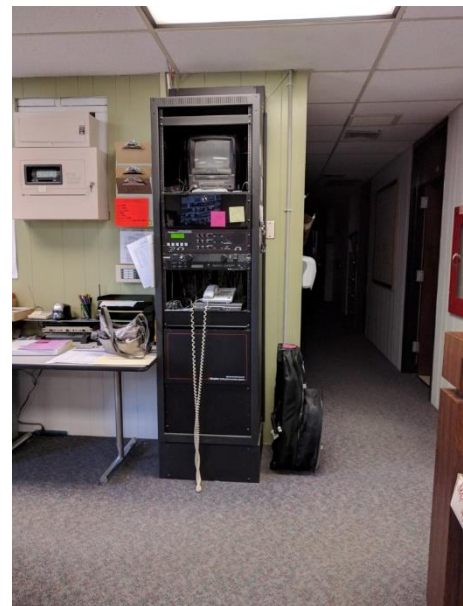
Photo: Public Address System

Replace existing system with new. Simplex no longer supports this system and parts will become increasingly harder to find in the future. Provide new system, with new speakers, new amplifiers, multizone control and a telephone interface

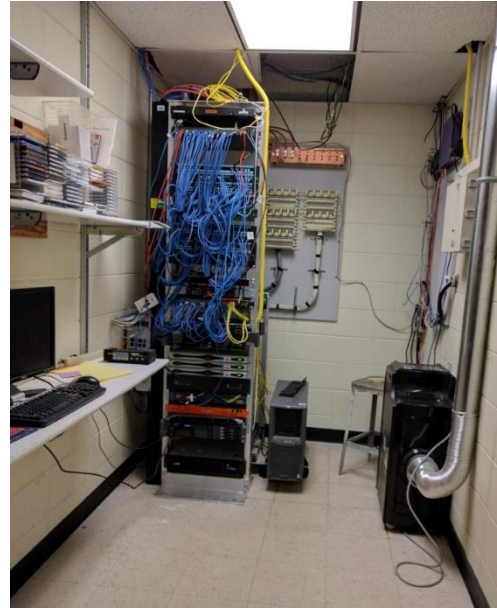
MDF room F116 contains building data service entrance. There is a two post rack in this room supporting switches, patch panels, video surveillance, VoIP switches and distance learning equipment. Backbone cabling is 6 pair of single mode fiber optic cabling. Horizontal cabling is done via Belden Cat 5E and Cat 6 cables. All appear to be in good condition.

Photo: Main Data Room

Existing equipment and cabling appears to be in good condition and has room for expansion. Minor modifications to rack mounted equipment and cable management are recommended.

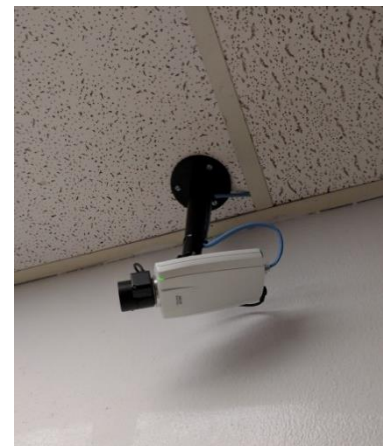
Photo: Typical Camera

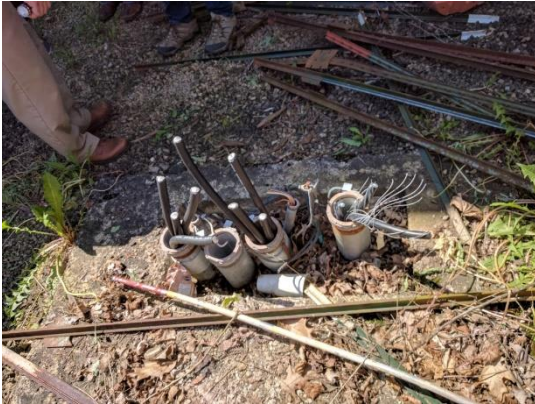
The main electrical service for this building is de-energized, and has been that way for an extended period of time. The existing utility pad mounted transformer has been removed and the service conductors cut off at ground level. In addition, the systems within the building have been partially to fully removed by a previous demolition/salvage contractor. The devices remaining have been in an unconditioned space and exposed to moisture due to a leaking roof. It is recommended that if building is to become occupied that all electrical systems be replaced. There is some value (copper feeders, ground wiring, busses and existing light fixtures) that remain in place and may have some salvage or as-is resale value.

Photo: Old Transformer Location

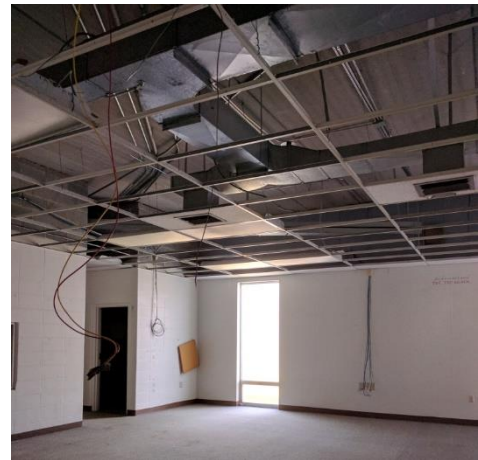
Photo: Typical semi-demolished space
