Facilities Assessment Report

July 25, 2017

Introduction

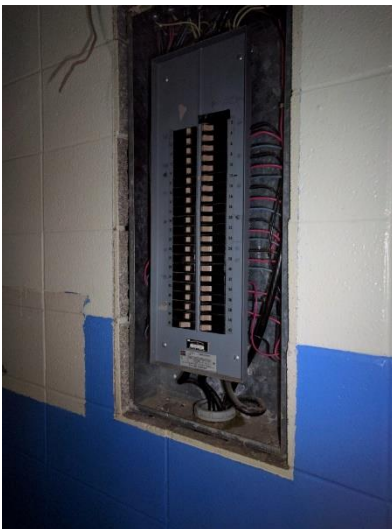
Photo: Panelboard

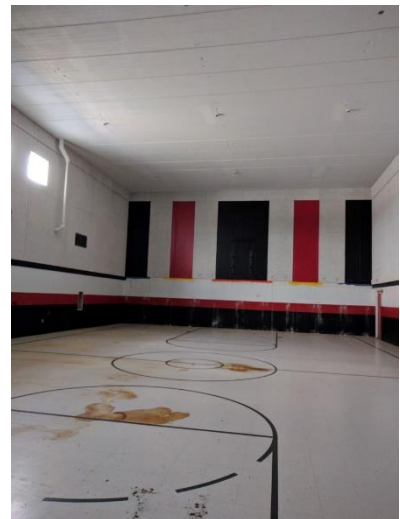
Photo: Gym (no light fixtures)
